Inspecting, Cleaning, and Rehabilitating Piping Infrastructure

Progressive Pipeline Management

Monday, March 11, 2024: Session 4

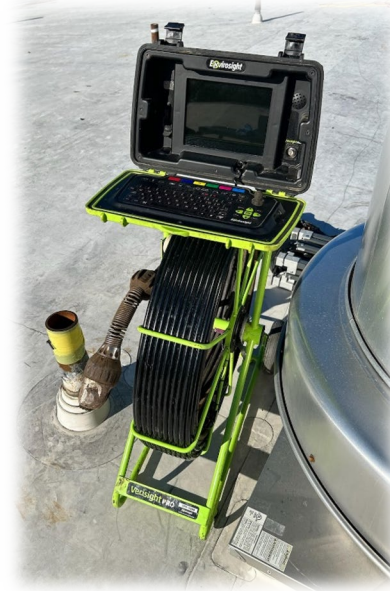
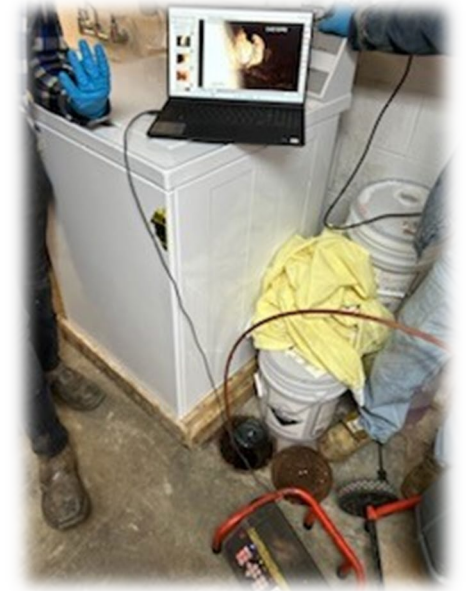
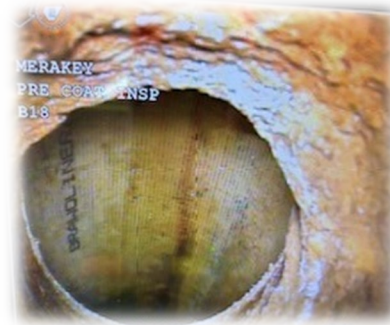
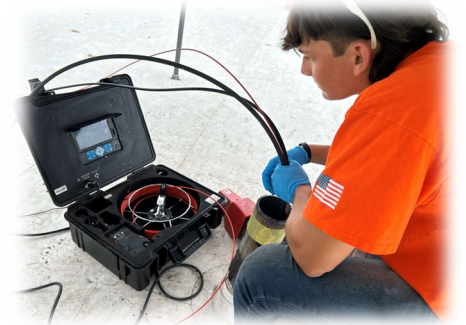
Closed-Circuit Television (CCTV) Inspections

CCTV inspections of in-building & underground pipelines offer a range of benefits and options for assessing the condition of pipelines ≥ 2 " in diameter.

- Assess the condition of pipelines and identify potential issues or defects.
- Prioritize maintenance and repair activities based on the severity of identified issues.
- Ensure the integrity, reliability, and safety of pipeline infrastructure.
- Facilitate proactive maintenance planning and asset management.

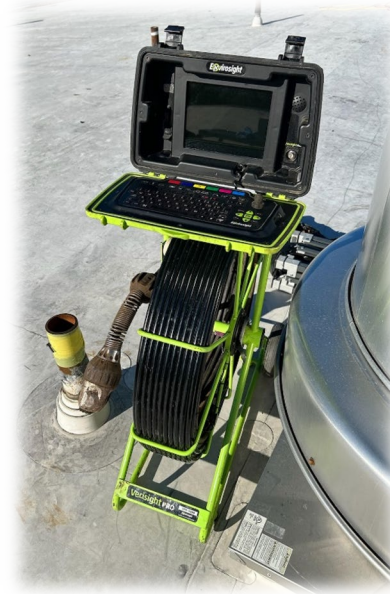
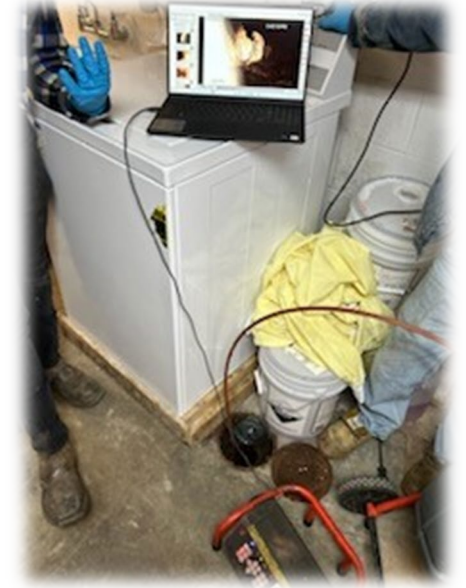
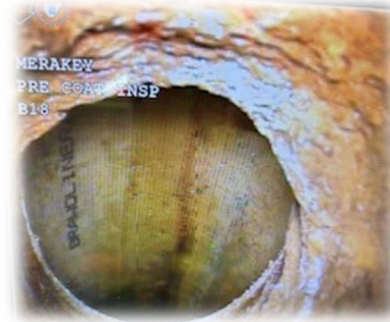
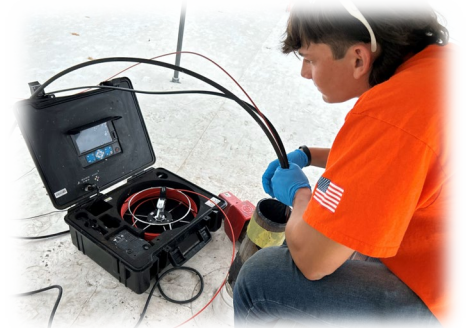
Closed-Circuit Television (CCTV) Inspections (continued)

CCTV cameras allow facilities teams to efficiently inspect pipelines and laterals with minimal disruptions – only an access point is needed.

- Design options:
 - Rugged/durable
 - Slim
 - Ultra Flexible
 - 50' to 325' in length
- Lighting and camera improvements
- Pan and Tilt functionality
- Cable-equipped
- Real-Time adjustments
- Digital Recording

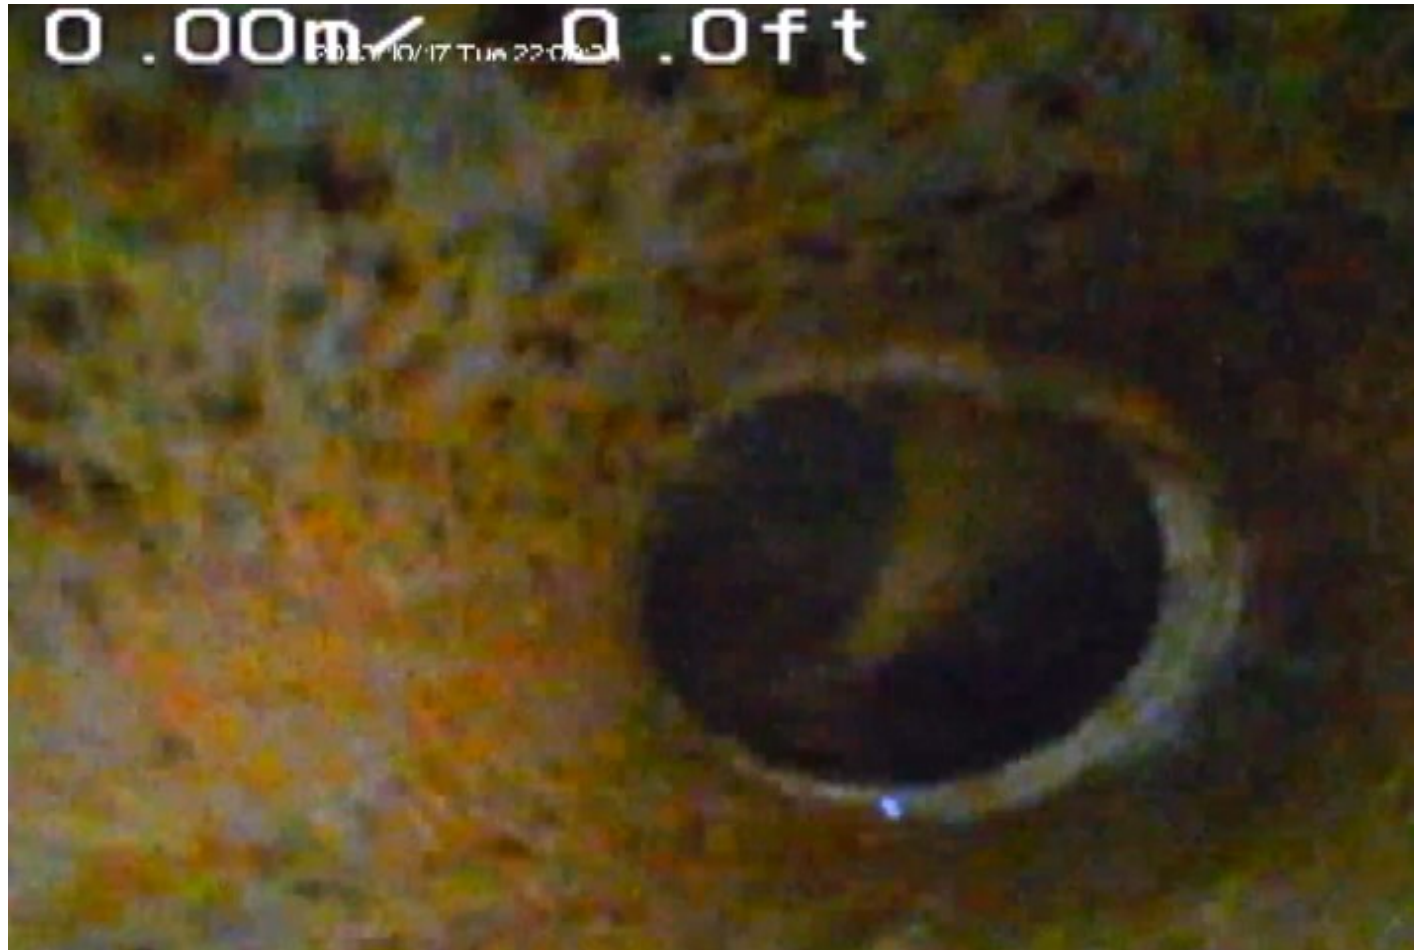
Potential Concerns Found By Inspection

- Blockages and debris
- Collapsed mains
- Offset joints & protruding laterals
- Unique piping configurations
- Cracks
- Heavy tuberculation
- Incorrect Drawings

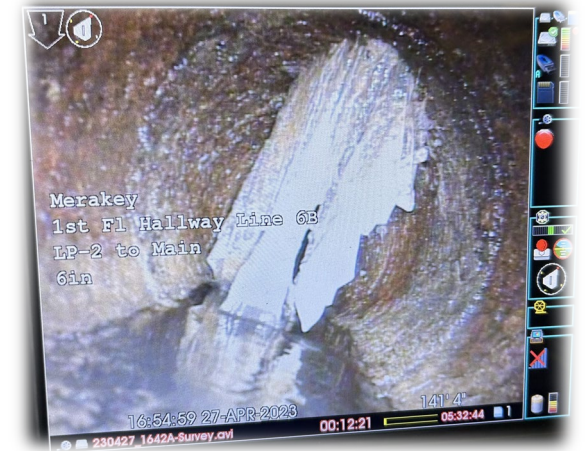
Potential Concerns:

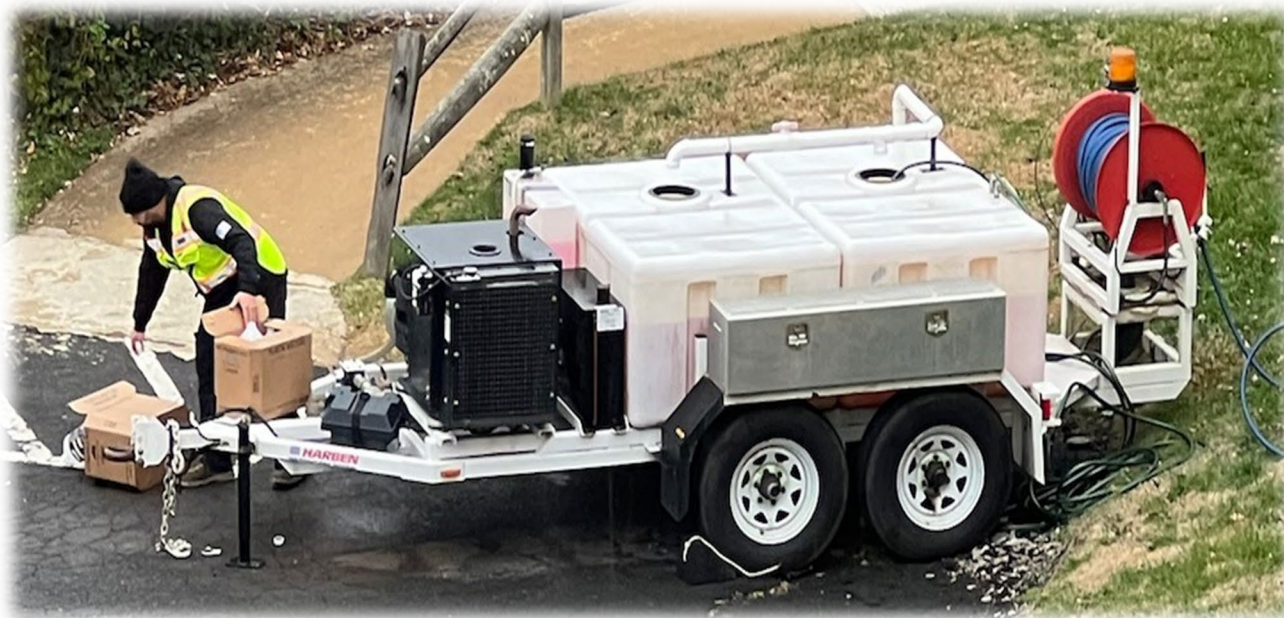
Harben Jetter – Tow Behind

High Pressure Water Jetting

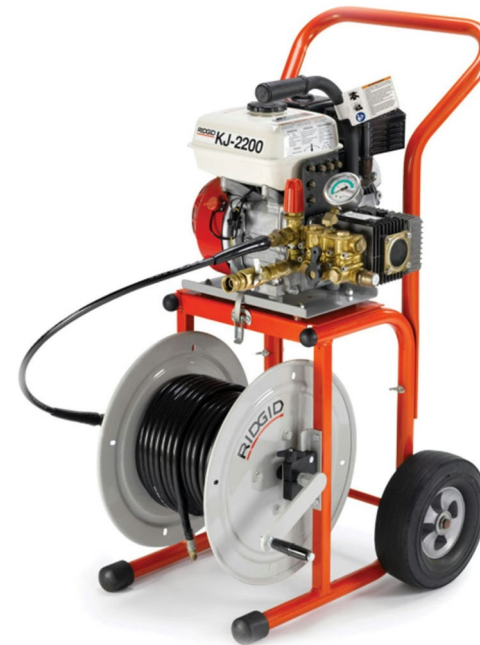
Gas

Portable Jetters

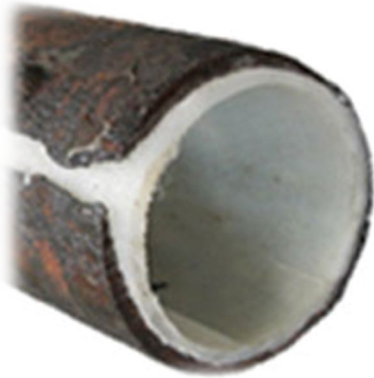
CIPP – Cured-In-Place-Pipe:

- Felt liner with pre-impregnated resin
- Creates a “pipe within a pipe”
- Provides *structural* rehabilitation
- Seals cracks and voids
- Stops root and water infiltration
- 50-year design life
- Ambient or Ultraviolet Light (UV) Cured

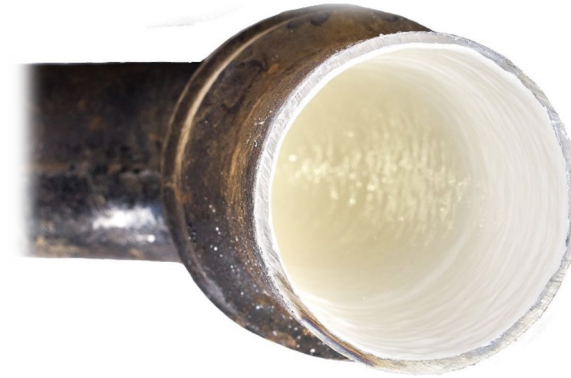
BIPP – Brushed-In-Place-Pipe:

- Corrosion Protection
- Extends life of pipe – reduces future issues
- Quick and effective installation process
- Low risk installation
- Suitable for smaller diameters, irregular configurations
- Can be applied in potable water mains
- Often used in vertical lines

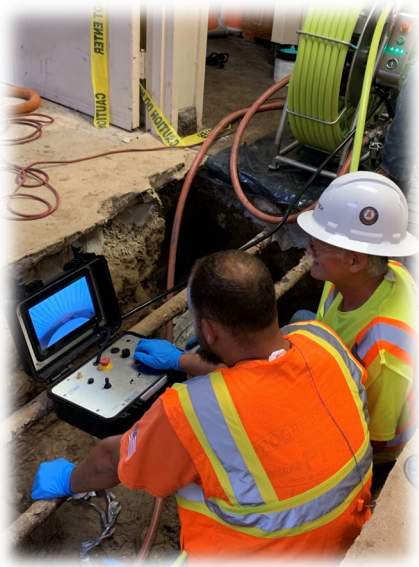
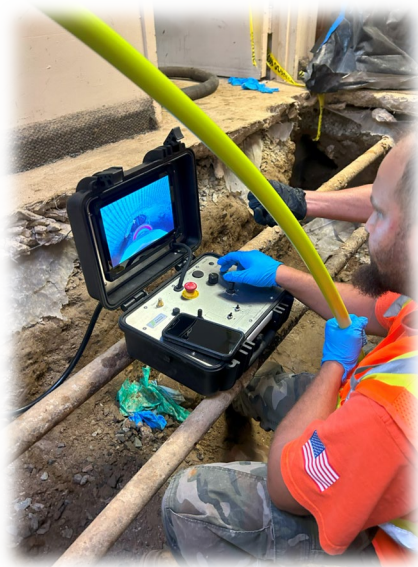
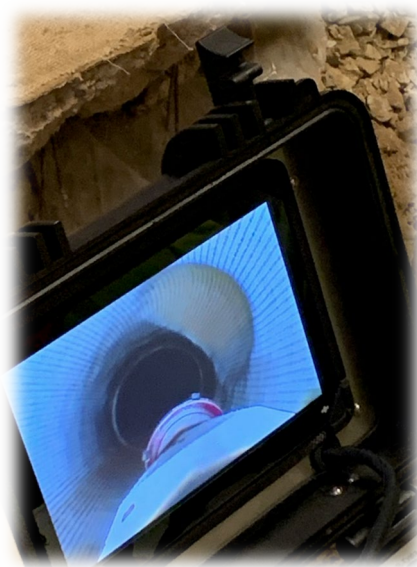
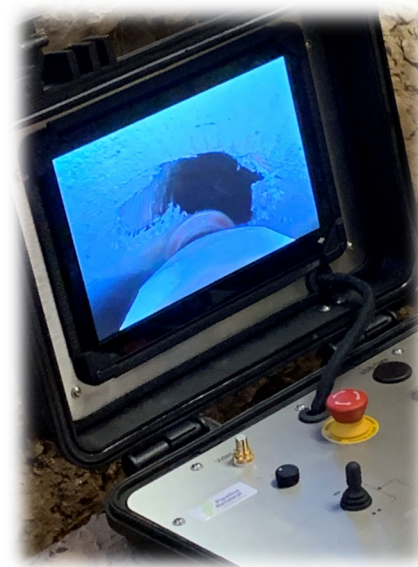
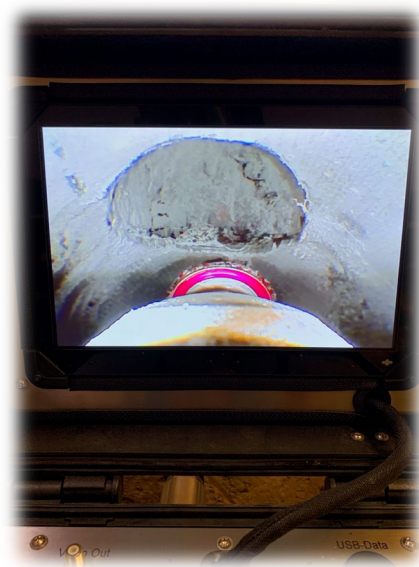
Connection Reinstatement Process

Reinstating Connecting Lines

- Pipe must not be severely deteriorated or collapsed
- Relies on host pipe for structure
- Limited access, trouble with sharp bends, multiple bends
- Liner will block any connections and therefore connections must be reinstated with cutting tool

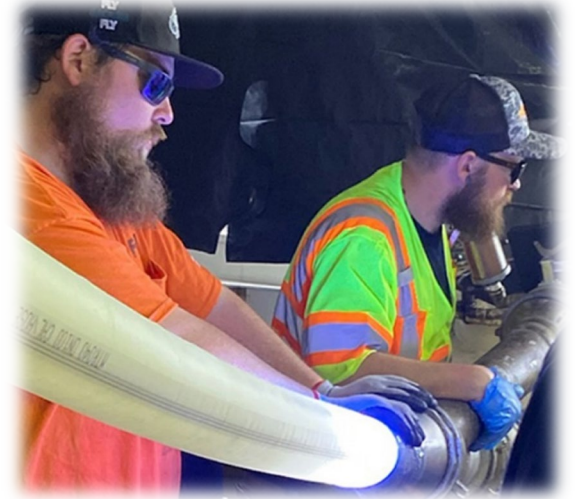
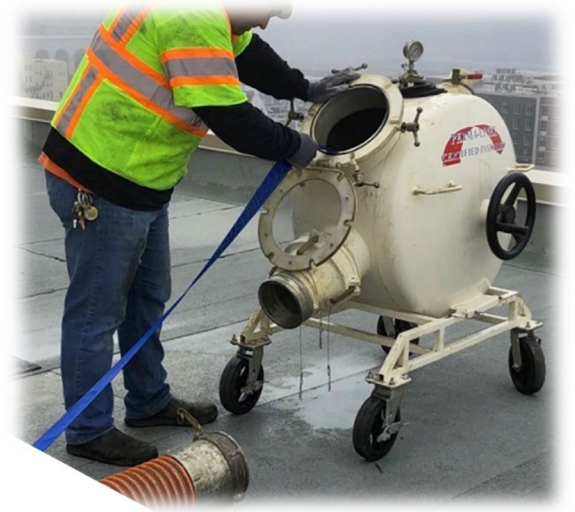
Case Study: CIPP – 637ft / 4” Roof Drains

- 15 story building with 150 residential condos & apartments.
- 60-year-old roof drain system, five cast iron drains, each 4” in diameter.
- Each roof drain is approximately 120’ long, vertical runs covering a total of 637’ of pipe.
- Roof drains leaked throughout the building walls and ceiling, causing excessive water damage.
- CCTV camera inspections revealed significant corrosion. Many lines were extremely brittle with multiple cracks.
- One section of pipe had a 3’ gap where the pipe had corroded completely away.

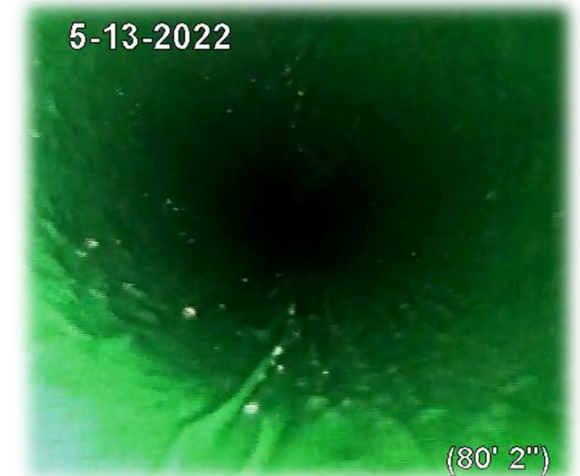
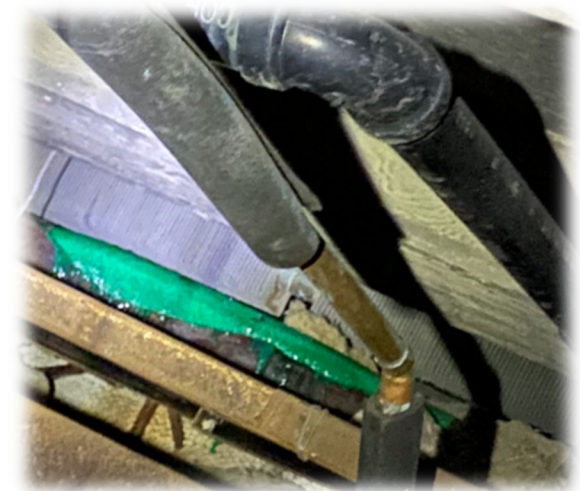
Case Study: CIPP – 637ft / 4” Roof Drains

- Following a CCTV inspection and cleaning, the liner was measured and cut to the exact specs of each pipe; soaked in resin; loaded into a pressure drum; then inverted and installed.
- To address the missing section of pipe, a PPM crew member climbed into a ceiling hatch to guide the inverted liner across the gap.
- A chain of ultraviolet (UV) lights on a cable was inserted from the inversion point to the end of the liner to fast-cure the resin.

- A post-CCTV inspection confirmed the liner was in place; formed a structurally sound CIPP within the host pipe; and had no obstructions.
- The entire project of lining and remediating the roof drains was completed without displacing the residents.
- The building owners avoided the high costs and disruption of the alternative ‘rip out and replace’.

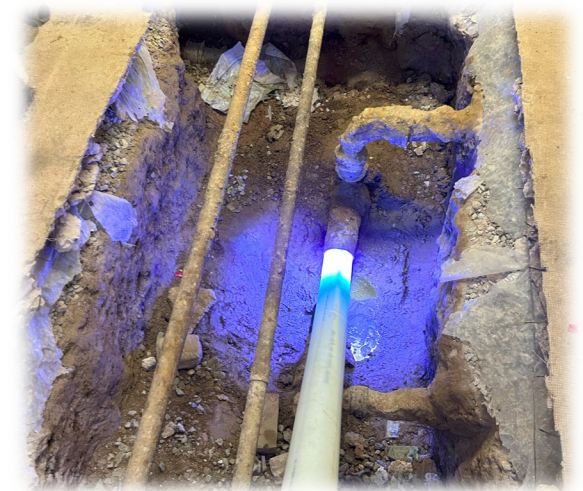
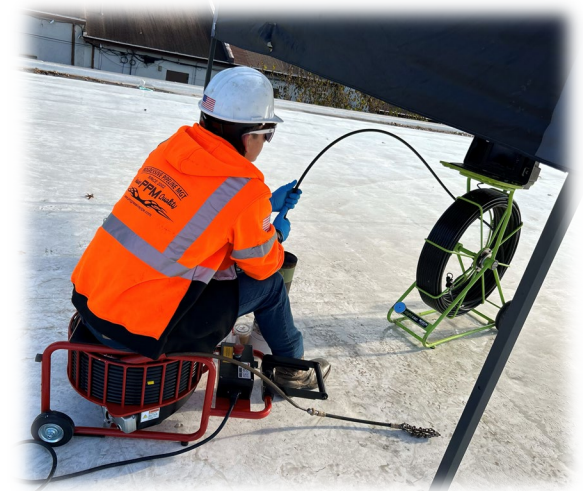
Case Study: UV CIPP: 2 Parallel Sewer Mains, 22 BIPP Connections

- 2 story building with 75 rooms for special needs residents.
- Drainage system backing up throughout the building. A solution was necessary.
- Prior 3rd party installer had incorrectly lined a section of pipe while the water was running, leading to a “shark fin” in the line.
- Excavation was necessary to remedy the situation. PPM was called in to complete the project.
- Two parallel horizontal mains stretching 350'. 6” to 8” to 10” mains.
- CCTV camera inspections revealed extreme tuberculation, system overflowing with wipes and debris.
- CCTV inspections of 22 connections showed corrosion, blockages, and brittle pipes in need of support.

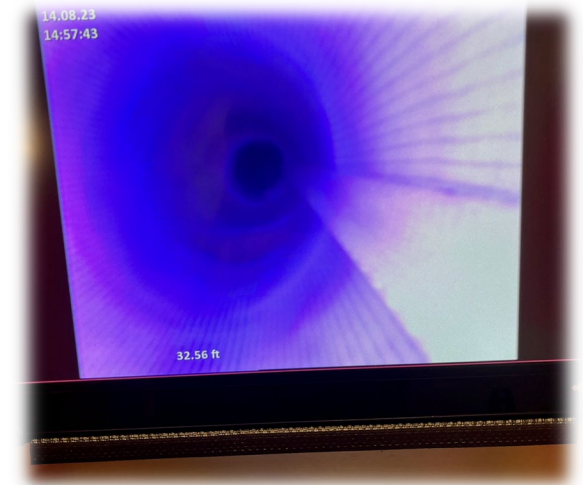
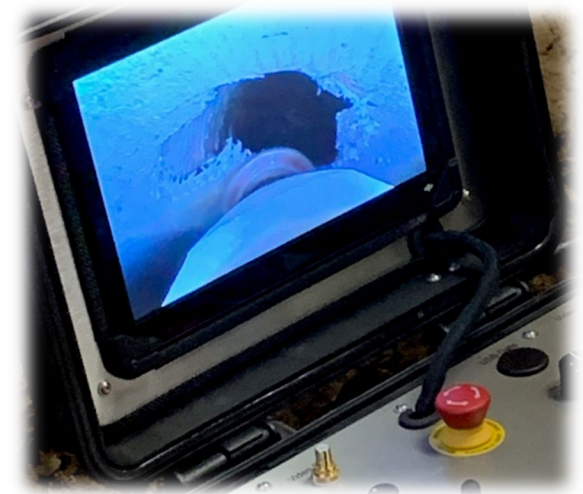
Case Study: UV CIPP: 2 Parallel Sewer Mains, 22 BIPP Connections

- CCTV inspection and heavy cleaning necessary. Multiple cleaning techniques needed – Harben jetter, chain knockers, sandpaper fins, and vacuum truck.
- Pits to be dug every 120’.
- UV CIPP lining of 7 sections. 6”, 6”-8”, 8” to 10”. Lines transitioned.
- Cleaning of 22 connections for BIPP process.
- Access panels and access points to be made on first floor.

- A post-CCTV inspection confirmed the liner was in place; formed a structurally sound CIPP within the host pipe; and had no obstructions.
- The entire project of lining and remediating the roof drains was completed with minimal disruption.
- The building owners avoided the high costs of displacing residents. Building was able to operate near to “as usual”.
